Manhole Inspection Summary

Manhole # S35Y1_024MH

Insp Date: **11/29/07 12:49 PM**

Location Address: **115 Riverside Road**

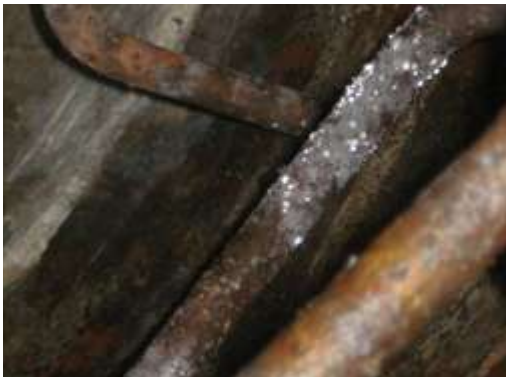
Defect 1

corroded steps

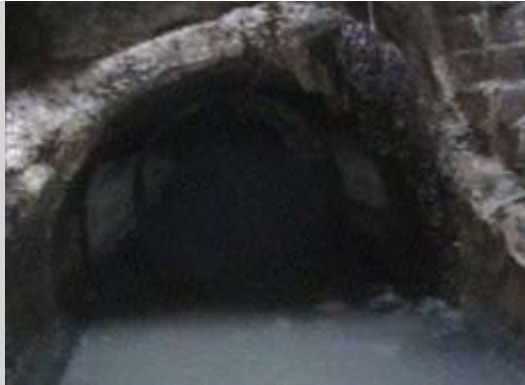
12 O'Clock Outflow

24 in. Circular Gravity Sewer
Pipe Out @ 12 O'Clock

Pipe Height: **24** (in.) Rod and Bar (Angled)
Pipe Material: **Clay** ☐ Pipe Lined
Invert Depth: **10.99** (ft.) Flow Characteristics: **Fast**
Deposits: ☒ None ☐ Mud ☐ Sludge ☐ Debris ☐ Grease
Silt Depth: (in.) Deposits Extent:
Infiltration: **None** Pipe Seal Cond: **Sound**

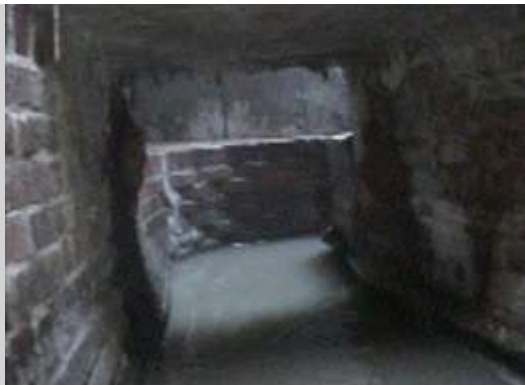
3 O'Clock Inflow

24.0 in. (w) x 24 in. (h) Horseshoe (inverted U) Gravity Sewer
Pipe In @ 3 O'Clock

Pipe Height: **26.4** (in.) Rod and Bar (Angled)
Pipe Material: **Clay** ☐ Pipe Lined
Invert Depth: **10.80** (ft.) Flow Characteristics: **Fast**
Deposits: ☒ None ☐ Mud ☐ Sludge ☐ Debris ☐ Grease
Silt Depth: (in.) Deposits Extent:
Infiltration: **None** Pipe Seal Cond: **Sound**

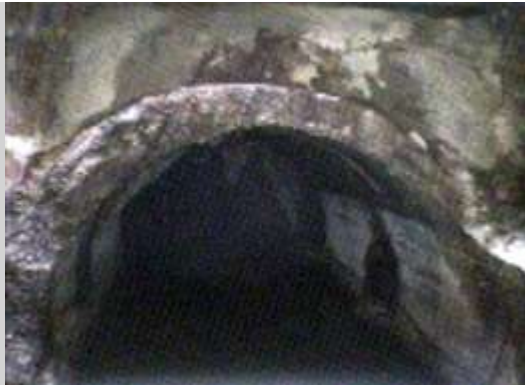
6 O'Clock Inflow

24 in. Circular Gravity Sewer
Pipe In @ 6 O'Clock

Pipe Height: **22.8** (in.) Rod and Bar (Angled)

Invert Depth: **10.95** (ft.) Flow Characteristics: **Fast**

Infiltration: **None** Pipe Seal Cond: **Sound**
